ACIFC Flooring Technical Note 01

Causes of Cracking in Concrete

This Flooring Technical Note considers the main causes of non-structural cracks in concrete. It focuses on the reasons for cracking in concrete which are not due to poorly designed floor details or operational overloading problems.

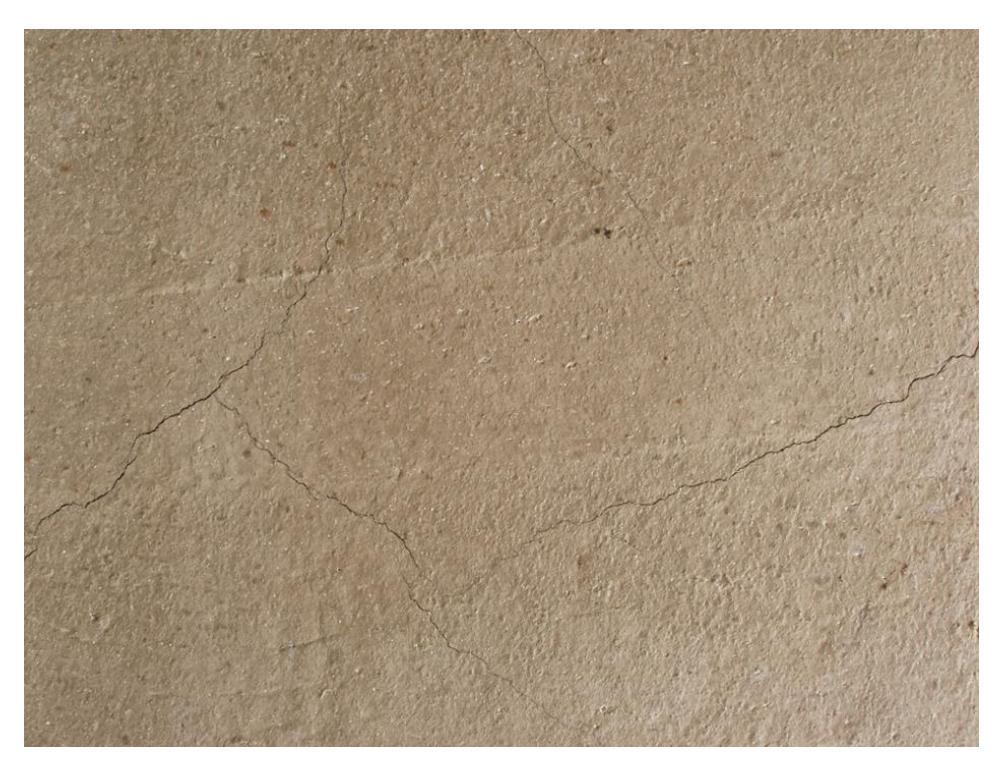
The following are deemed as the main groups of non-structural cracks in concrete:

1) Plastic Shrinkage Cracking (before concrete hardening)

2) Plastic Settlement Cracking (before concrete hardening)

3) Early Thermal Contraction Cracks (after hardening)

4) Long Term Drying Shrinkage Cracks (after hardening)
